# Water utilities

United Utilities.  
Accrington, UK

## JD7 Investigator+ pipe inspection and leak-detection system

Survey reveals tuberculation at water treatment works

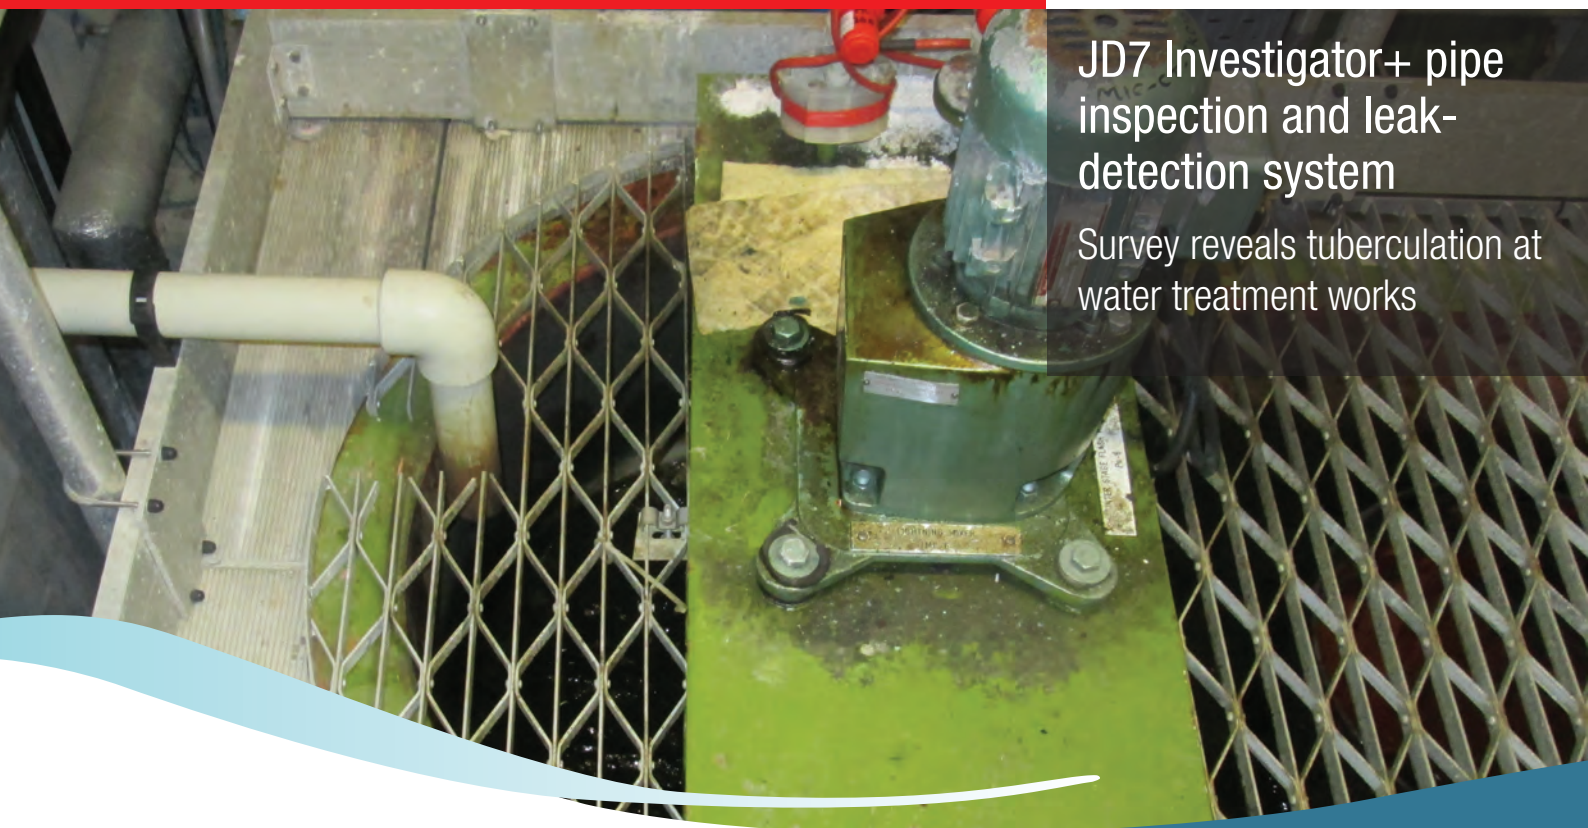
Throughout the area investigated on the joints and pipe sections, tuberculation was clearly visible. Tuberculation consists of small reddish brown mounds of corrosion -  $\text{Fe}(\text{OH})_3$  - on the inside of iron pipes. It makes the interior of pipes rough, which can increase pumping costs and reduce pressure in the distribution system. In severe cases, tuberculation can cause pipelines to leak. It can be prevented by chemical treatment or the use of cement mortar lining.

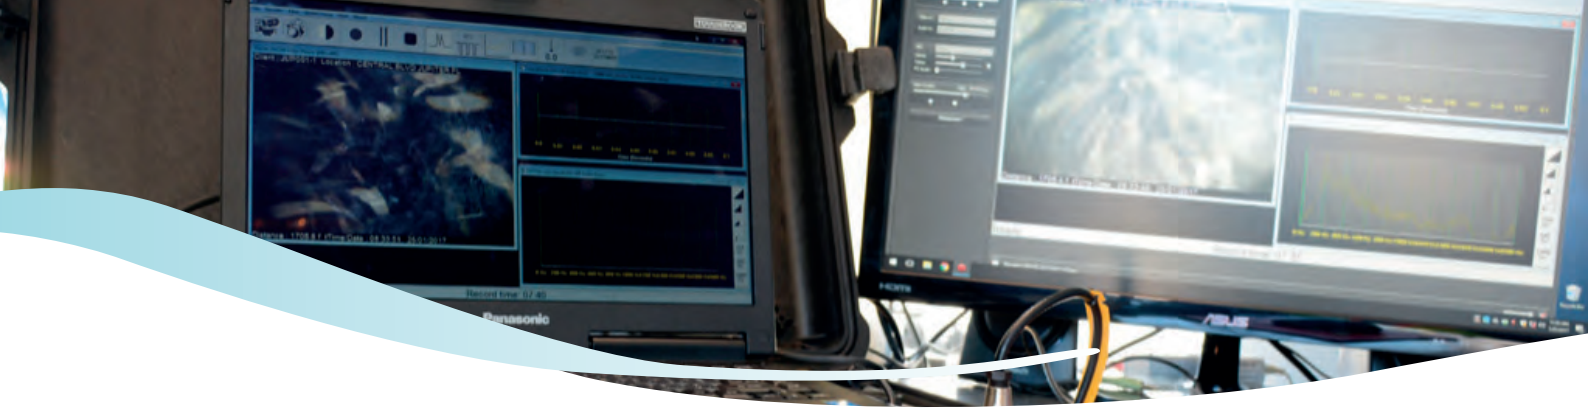
Although only a limited distance was achievable towards the bottom of the section, it was enough to reveal the situation.

Inspection of the interstage mixer revealed a similar picture of tuberculation, with a trapped air bubble in the joint increasing corrosion through oxidization, the final stage of tuberculation.
