Southern Water

Health, Safety & Security alert: fire hydrants

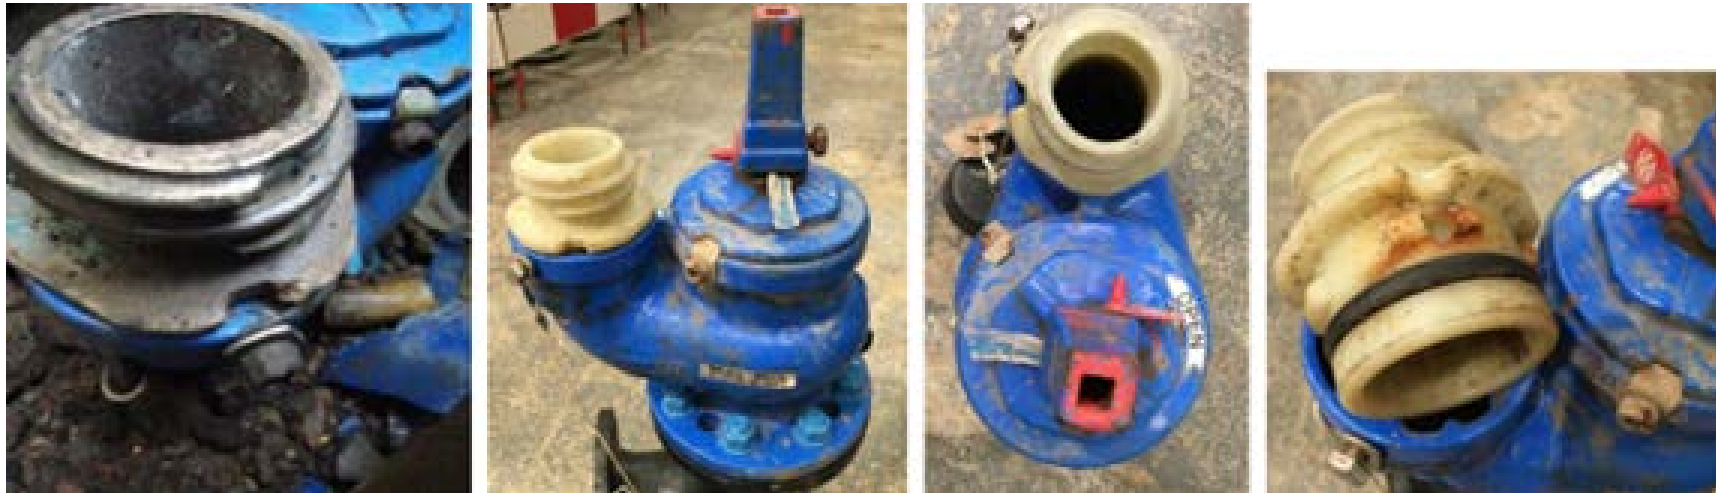
Series 19 Hydrants

The threaded outlet has a bayonet connection to the body and is not bolted down. Over time the locking screw can degrade, allowing the outlet to rotate to the unlocked position and if under pressure.

As a result the outlet can unexpectedly shoot up with great force. There have been several such incidents which have resulted in harm from units installed in other companies' water networks.

- Inspect hydrants to see if it is a Series 19 hydrant.
- The outlet and the valve bonnet of a Series 19 hydrant both have a bayonet connection, like a camera lens, instead of large vertical screws.
- The outer lip of the outlet and bonnet of a Series 19 hydrant have a locating notch for a small safety clip. The safety clip is held in place by the small horizontal screw that passes through the hydrant body and stops the bayonet from unlocking. *See diagram right.*
- If a hydrant has several hexagonal bolt heads visible from above, it is **NOT** affected by this Safety Alert

If you identify a S19 hydrant **DO NOT** use it.

Highlight it is a S19 hydrant to warn others not to use it.

Raise a hazard, escalate to your manager and raise a job for the valve to be replaced by third party.
