Water utilities

Severn Trent Water. Church Preen, Shropshire, UK

Whirlwind pipe cleaning technology

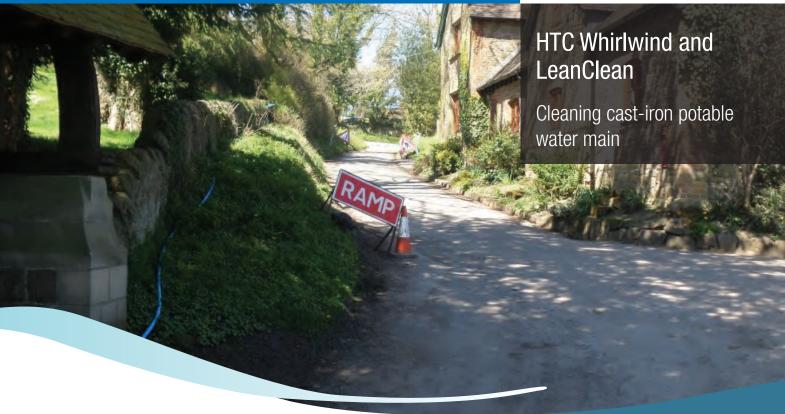
A village in Shropshire where discoloured water was a persistent issue has become one of the first in the UK to benefit from an innovative pipe cleaning technology. Utility Severn Trent Water worked with Aquam to trial its technology by clearing and chlorinating sections of 30-year-old unlined cast iron pipe in Church Preen.

The trial was carried out using its HTC Whirlwind system, which blasts a fine granite dust to remove corrosion and restore the pipe to its original diameter, together with the Leanclean system, which flushes and chlorinates the pipe.

The team from Aquam used Tornado, a vehicle-mounted mobile unit to blast the dried 10mm granite aggregate using the Whirlwind forced vortex. The Tornado unit was sited at a central point, in order to blast clean the pipe in both directions.

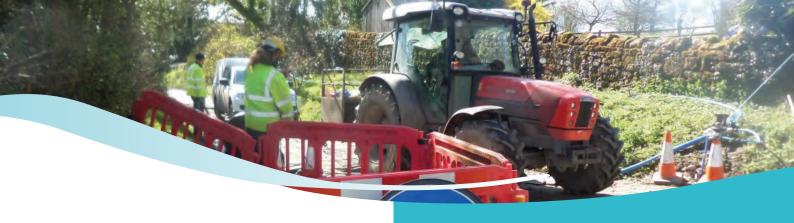
HTC's Whirlwind is a forced air vortex pipe cleaning system which uses granite aggregate to remove corrosion. In a single operation one kilometre of pipe can be cleared - at lower cost than existing systems and with less disruption to customers.

Two diesel engines mounted on the rig power blowers use a vortex to create a turbulent airflow. Dry granite aggregate of 10mm diameter is blown along the pipe length, hitting the walls and sweeping away tubercles as it travels - restoring the pipe to its original diameter.
